**Low- and intermediate level radioactive waste  
from Risø, Denmark. Location studies for  
potential disposal areas. Report no. 4**

Characterization and description of areas  
Bornholm

Peter Gravesen, Bertel Nilsson,  
Stig A. Schack Pedersen  
& Merete Binderup

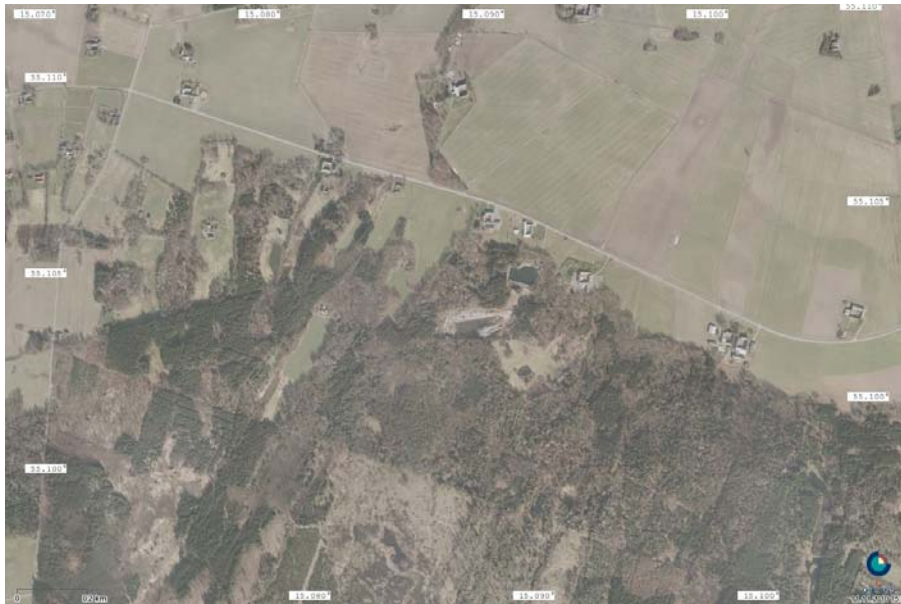
*Figure 4. Orthophoto of the northern rim of the Paradisbakkerne showing the migmatite quarries at Præstebo and Bertelegaard. The Quarries are partly filled with water and look like small lakes on the photo (From GEUS Home page).*

The surface geology is dominated by a Quaternary cover consisting of clayey and sandy tills over gneissic and migmatitic rocks and only few outcrops. Just outside the area, the Præstebo and Bertelegaard quarries, located in the rim of the Paradisbakkerne area, demonstrate the rocks and structures (Figs. 3 and 4). The Paradisbakkerne is a higher area (up to 113 m above sea level) cut by a series of NE-SW oriented linear

The Paradisbakke Migmatite (described as gneiss by some authors) is best exposed in the Præstebo and Bertelegaard quarries located at the rim of the Paradisbakkerne (Fig. 4) while the Bornholm Gneiss is exposed along the coast from Listed to Saltuna where the boundary between the gneiss and the Svaneke Granite can be recognized.

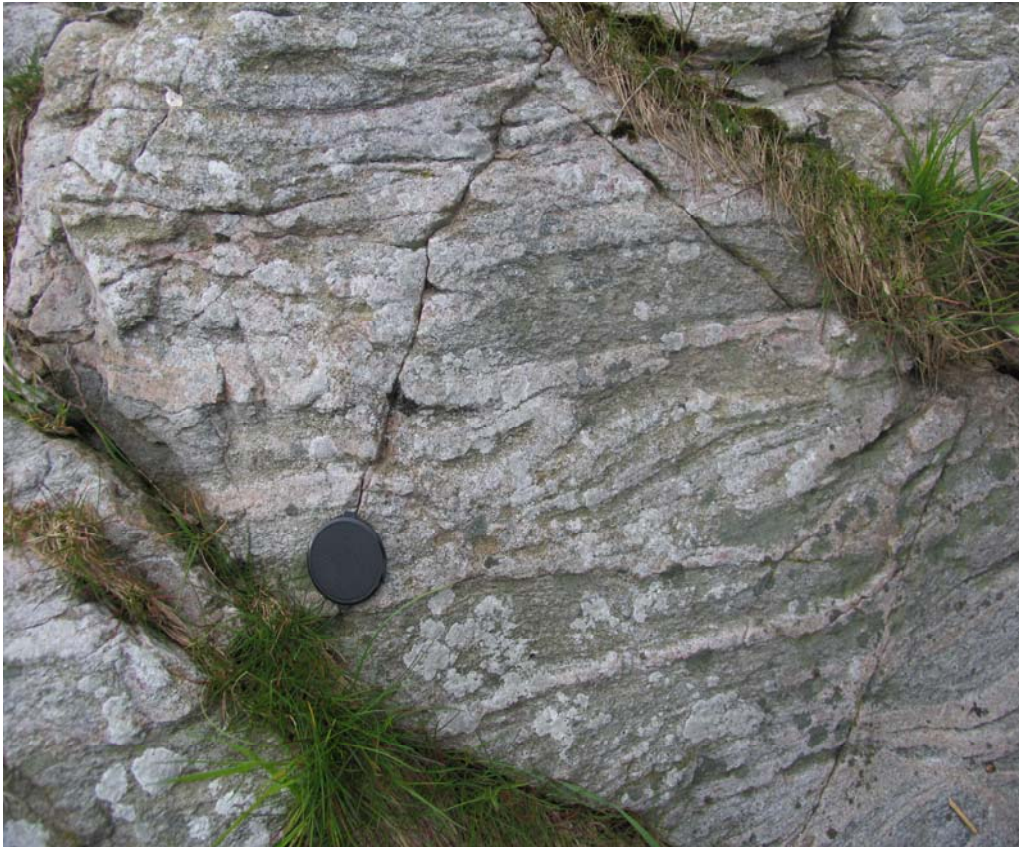
*Figure 8. Folded Bornholm biotite gneiss west of Listed.*

The Bornholm Gneiss, mainly medium-grained, consists of several gneiss types (Fig. 8 and 9):

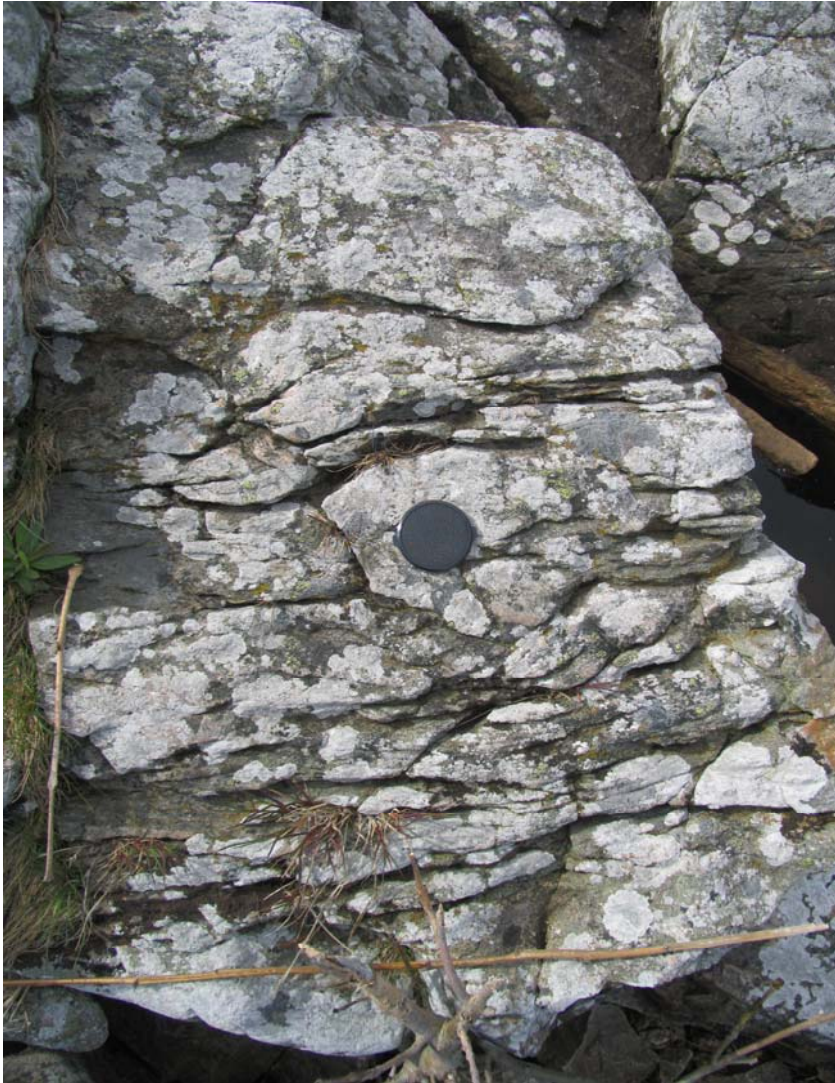
*Figure 9. Schistose Bornholm gneiss west of Listed.*

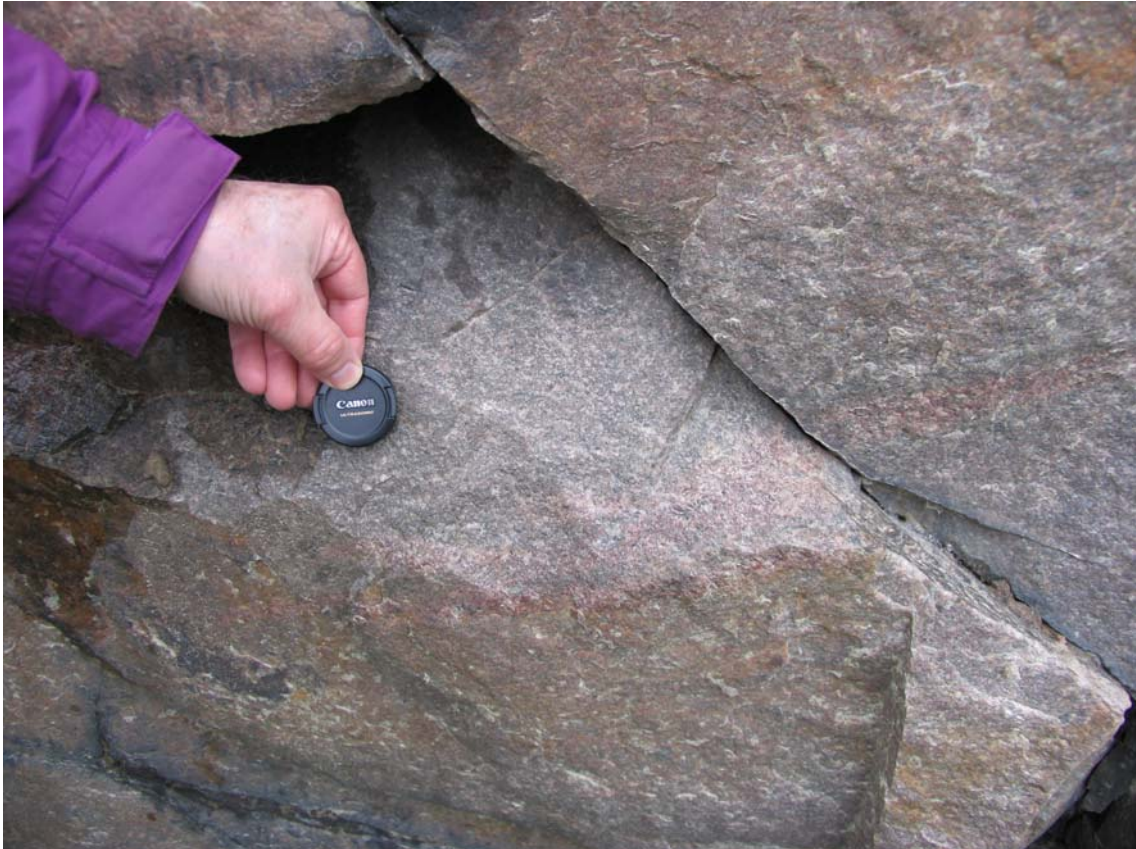
Figure 10. Medium-grained red grey granite in the gneiss area at Østerlars.

The gneisses often contain other rock types as the granite near Østerlars (Fig. 10).

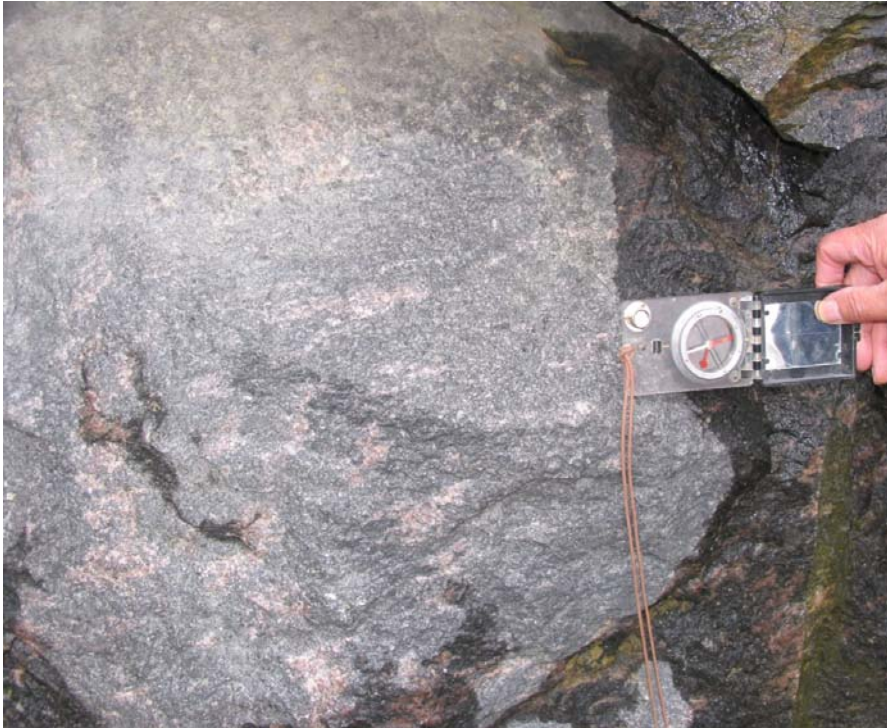
*Figure 11. Grey and red, foliated, flame Paradisbakke Migmatite from Præstebo Quarry, the northern rim of the Paradisbakkerne area.*

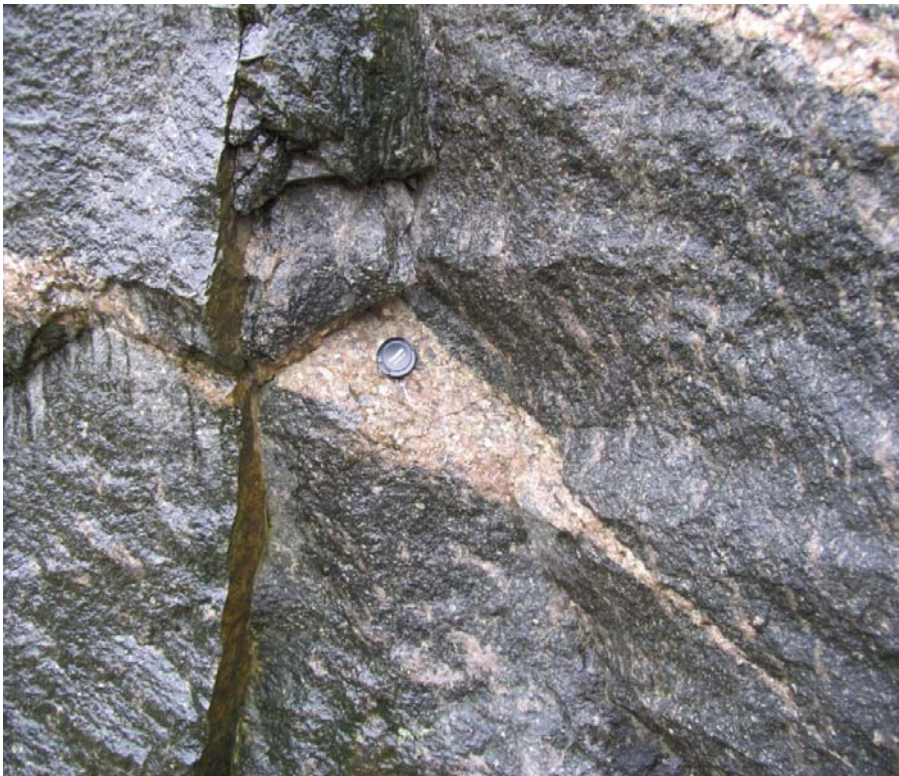
*Figure 12. Thin red grey pegmatite vein in the Paradisbakke Migmatite, Bertelegaard, northern rim of Paradisbakkerne.*

Other lenses contributing to the gneisses and the migmatite are coarse-grained pegmatitic and fine-grained aplitic veins as smaller isolated bodies (Fig. 12) or as larger longer pegmatite veins (Fig. 13). The pegmatites and aplites contain 30–40 % quartz, 45–60 % perthite, 10–20 % plagioclase and low content or traces of dark minerals ore, sphene, apatite, epidote and fluorite including gadolinite.

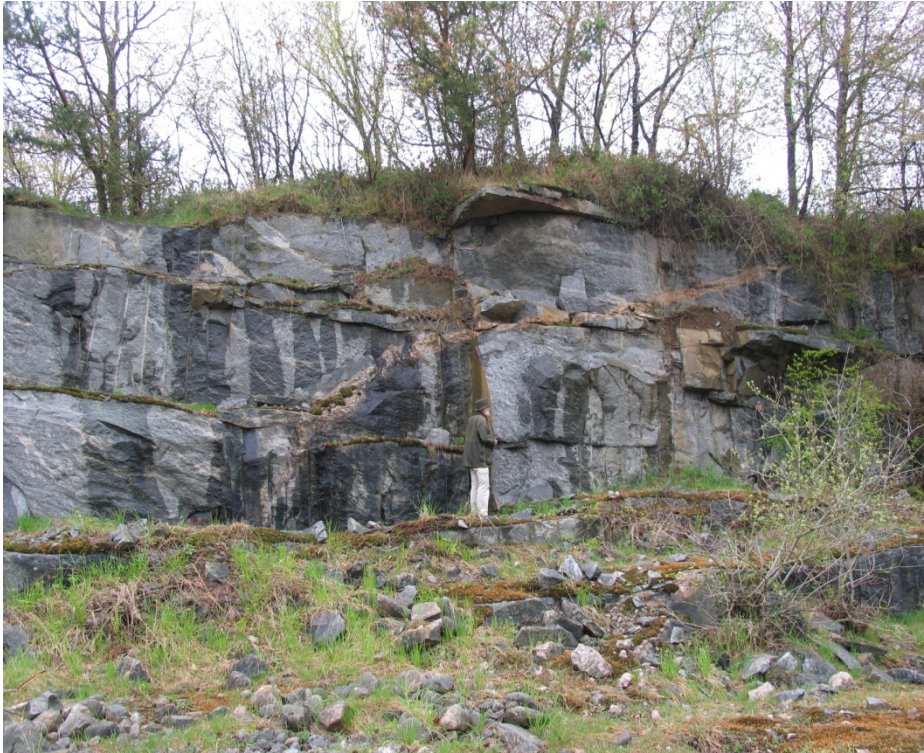
*Figure 13. A long red grey pegmatite vein in the Paradisbakke Migmatite, Bertelegard Quarry, northern part of Paradisbakkerne.*

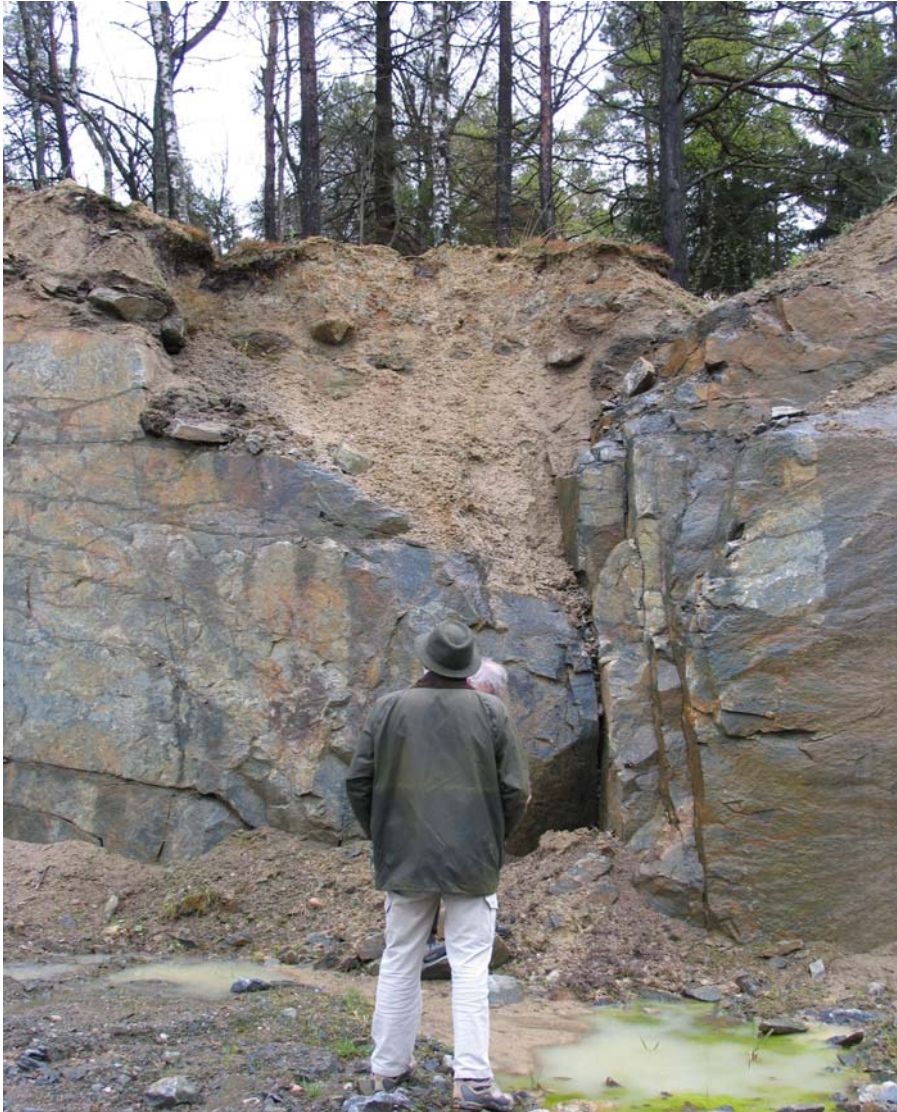
*Figure 15. In the Præstebo Quarry only a thin cover of Quaternary sandy till occur over the migmatite.*

The Quaternary sediments in the area consists mainly of glacial tills deposited during the Weichselian (the last glacial). The cover over the Precambrian rocks seems to be rather continuous (Figs. 3 and 14). Nevertheless, the thickness varies from no cover in a few places to 17 m in small stream valleys. In the Præstebo and Bertelegaard quarries, the migmatites are overlaid by sandy and clayey, often very gravely and stony, tills (Fig. 15). Samples from the boreholes also show a dominance of clayey tills described

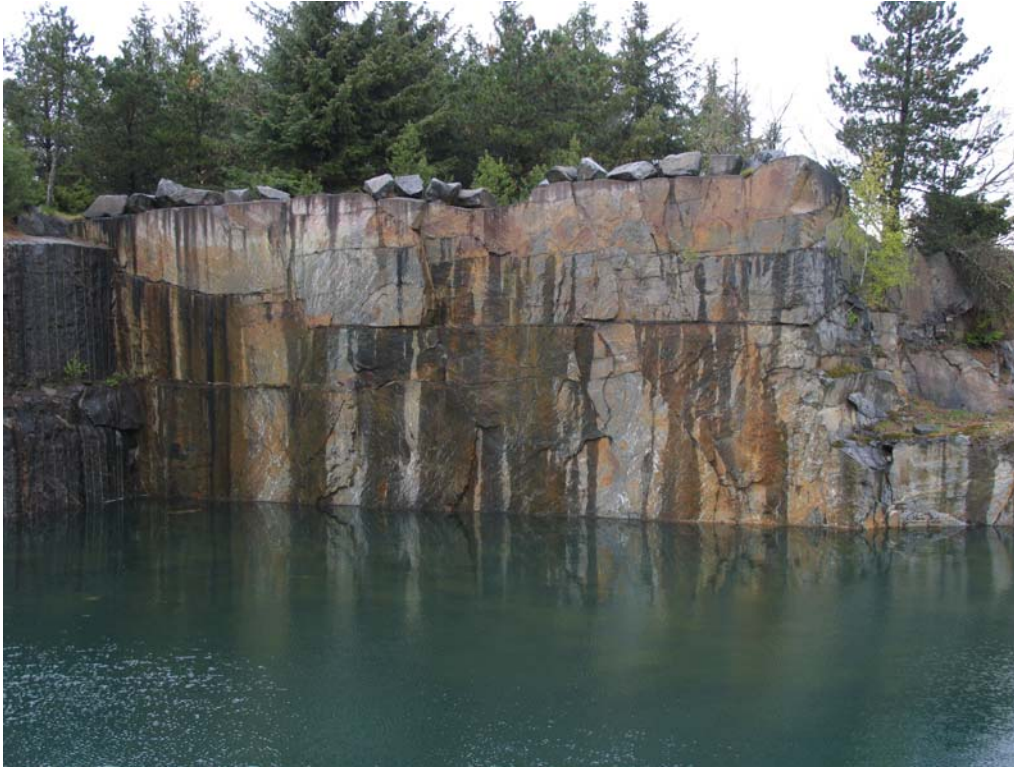
*Figure 17. Section of the Paradisbakke Migmatite in the Præstebo quarry (high approx. 12 m). Spacing's of prominent horizontal fractures are increasing downwards.*

Based on preliminary observations from Præstebo and Bertelegård quarries and the north coast of the area, the following is suggested (Figs. 17, 18 and 19).

The thickest section of 12–15 m below surface is seen in fig 17. Some information about the deeper layers can be received from logs in Østermarie Water Work boreholes, just outside the area (Figs. 25 and 26). Gamma logs, Resistivity logs and Flow logs give indications of fracture zones and zones of weathering. High flow log values indicate fracture zones 19.0–22.0 m, 25.0–25.5 m and 37.0–37.5 m, High gamma values and low resistivity values indicate clay weathered rocks in fracture zones in e.g. 25 m, 29.5 m, 31 m and 36.7 m. The log types do not indicate the orientation of the fractures but the general picture is that the amount of fractures is decreasing below 25 m depth and is very low below 40 meters under the surface. High gamma values indicate pegmatites with high feldspar, mica and occasionally radioactive minerals. High iron values in the groundwater also indicate weathering of the gneiss. Moreover, weathered rocks in outcrops have often a high content of oxidised iron.

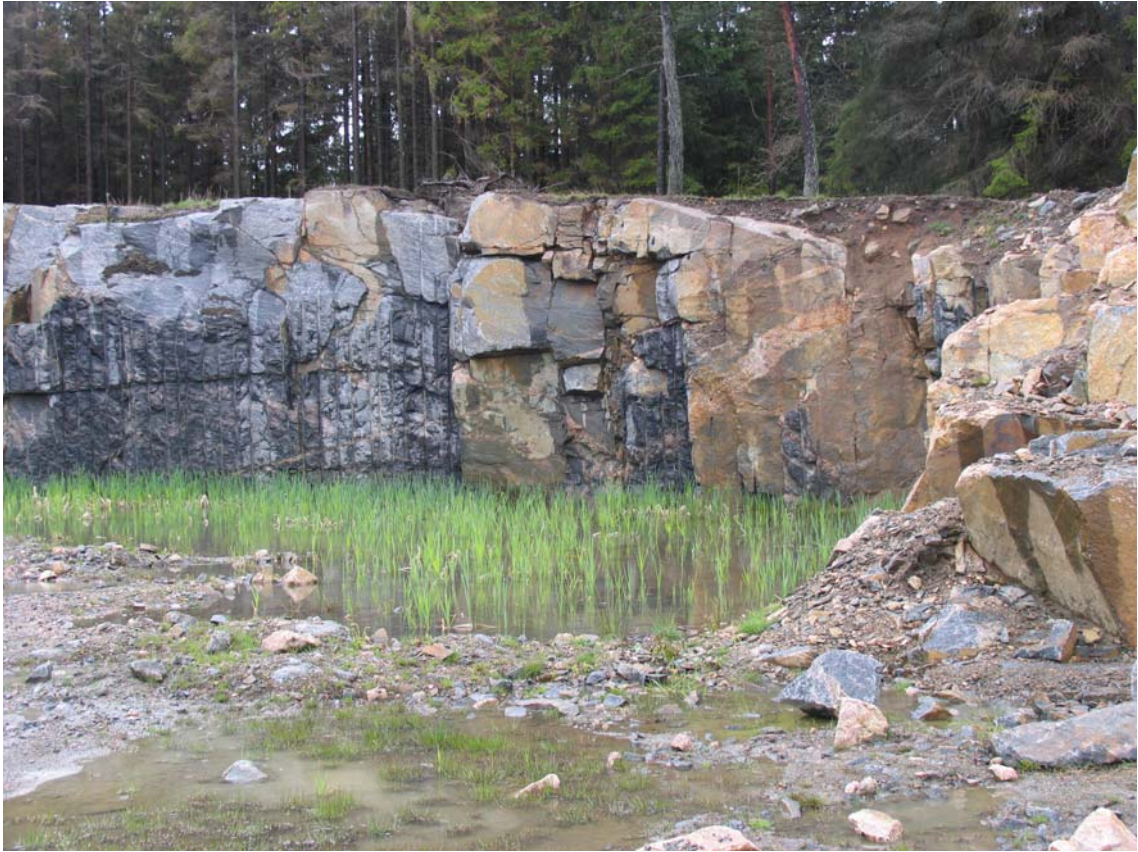
*Figure 18. Section from Præstebo quarry with vertical and horizontal fractures. The spacing of the vertical fractures is changing from very small (cm size) to a spacing of several metres. Only one horizontal fracture is seen in the approx. 3 m high section.*

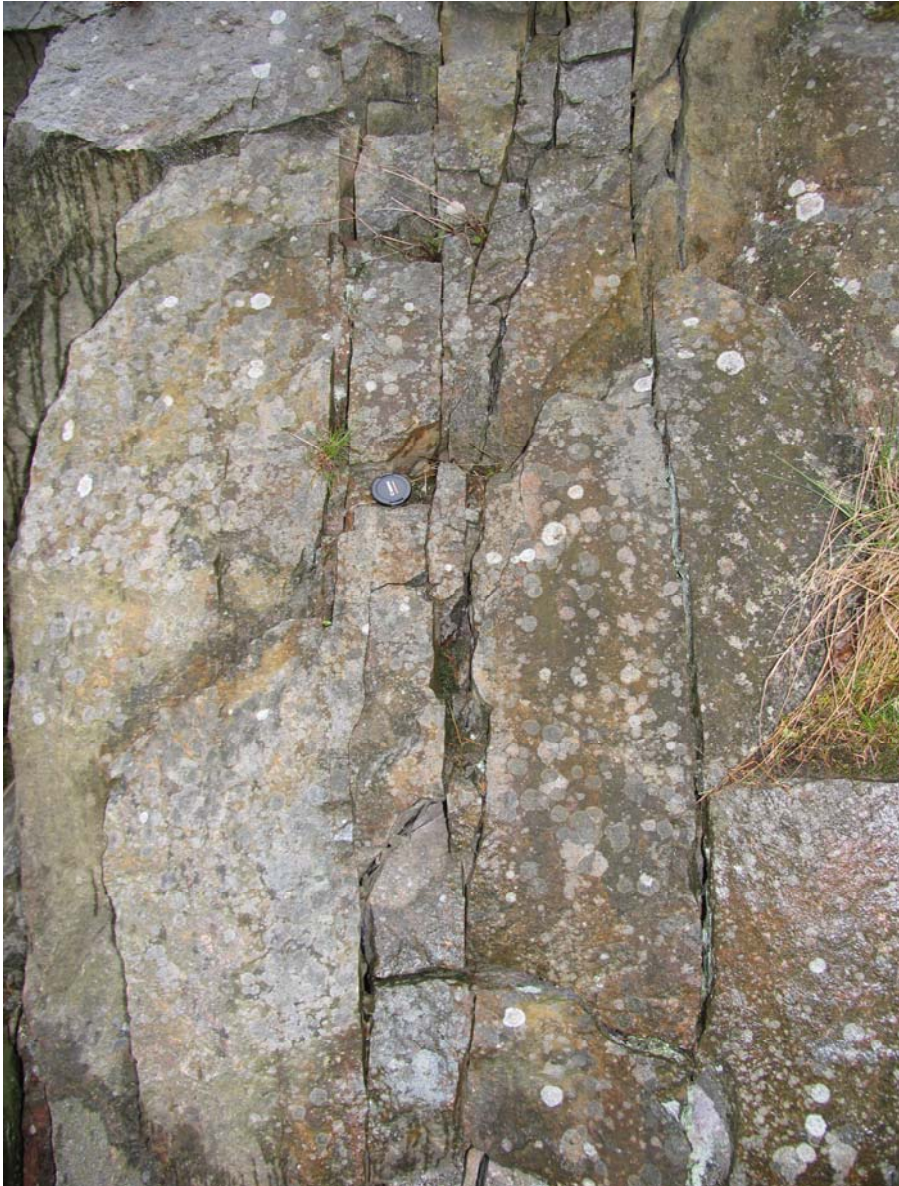
*Figure 19. Vertical fracture zone in Paradisbakke Migmatite, Præstebo Quarry.*

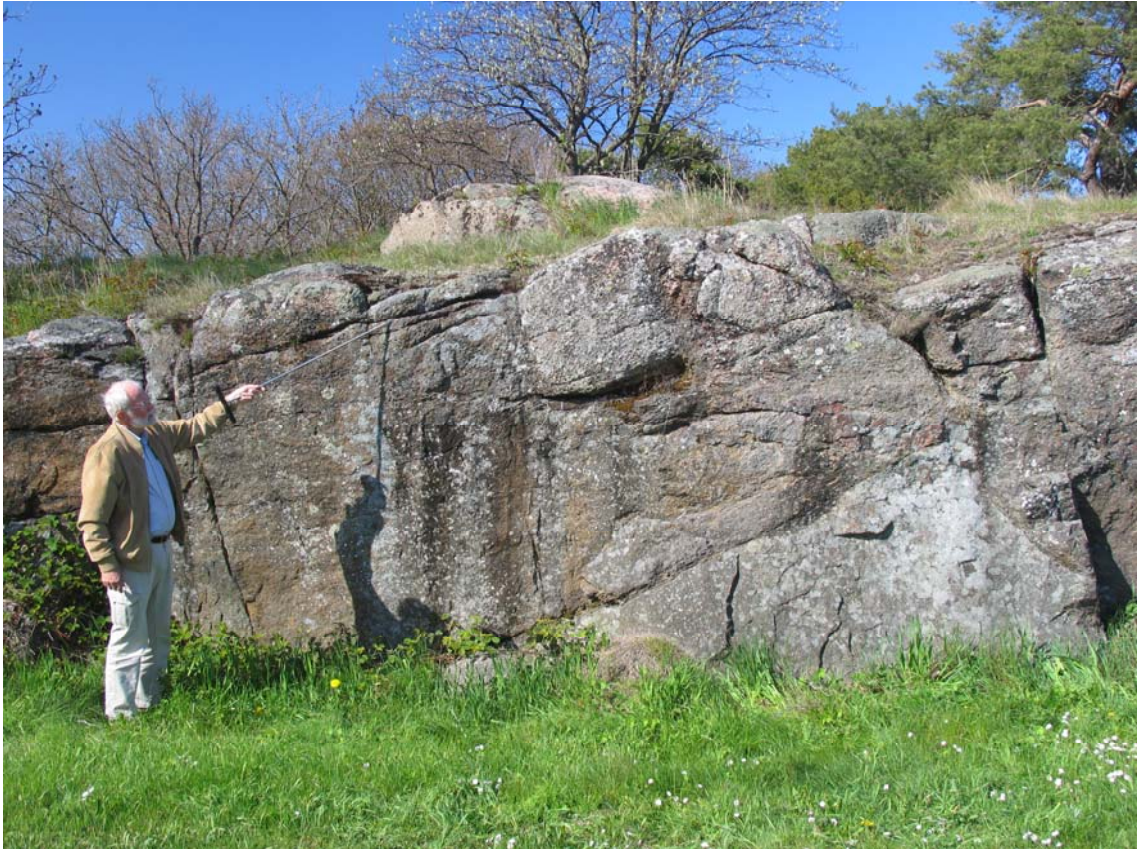
*Figure 21. Section in Bornholm gneiss west of Listed. The exposure forms a rock moutonnée, a glaciomorphological feature formed by Weichselian glaciers.*

The anatomizing fracturing of the surface is responsible for the glacio-morphological features known as rock moutonnée (Fig. 21). The till is in some places overlain by Holocene deposits. In general, it is expected to affect the basement rocks to a depth about 25 m below surface.

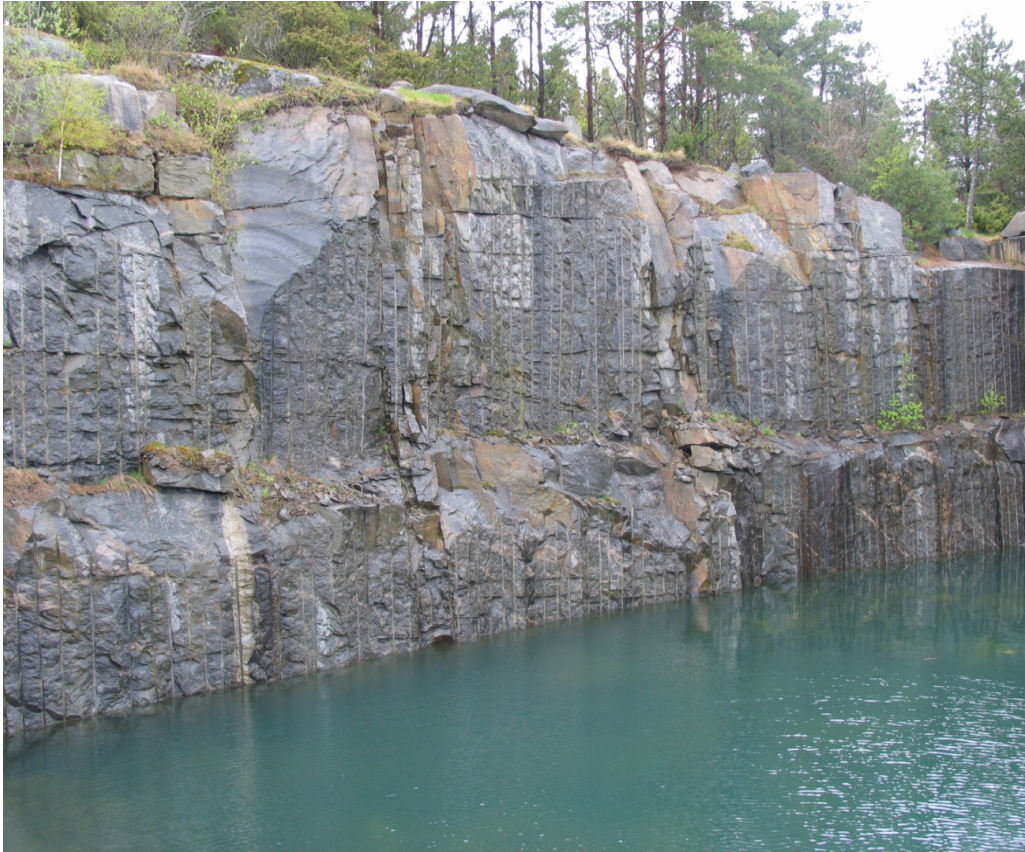
*Figure 22. Paradisbakke Migmatite/Gneiss from the Præstebo Quarry, northern part of Paradisbakkerne. The migmatite/gneiss is cut by several vertical fractures but only by few horizontal fractures.*

In the Præstebo area, the metamorphic fabrics are a general nature of the basement rock, which has no or very little effect on the hydrodynamic conditions in the subsurface. The spacing of the vertical jointing varies from cm to 5 m. This is the smallest frequency of vertical fractures recognized on Bornholm during the present investigation. The glaciotectonic fracturing resulted in rhombohedral shaped segments with the maximum thickness 1–3 m and a length in the order of 5–10 m. (Fig. 22)

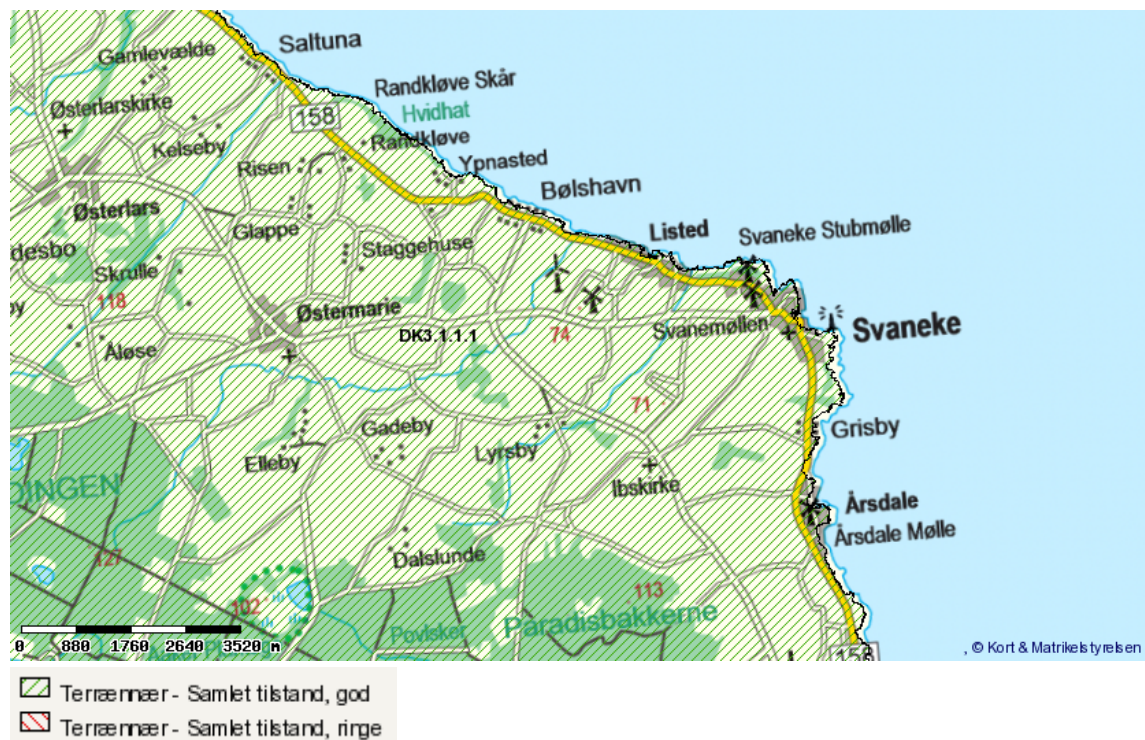
Figure 24. Shallow (or terrain near) groundwater body DK3.1.1.1. Area 1 is placed North of Paradisbakkerne, and between Østermarie and Svaneke. (From Ministry of Environment, 2010)

The East Bornholm site (Area 1) is positioned in an area that is characterized by presence of one shallow groundwater body (DK 3.1.1.1: Groundwater body Code of the Ministry of Environment) covering the entire Bornholm (Fig. 24) and one regional groundwater body (DK 3.1.2.3), that covers most of the northern part of Bornholm (Fig. 25). There is no deep groundwater bodies identified at the island Bornholm. The shal-

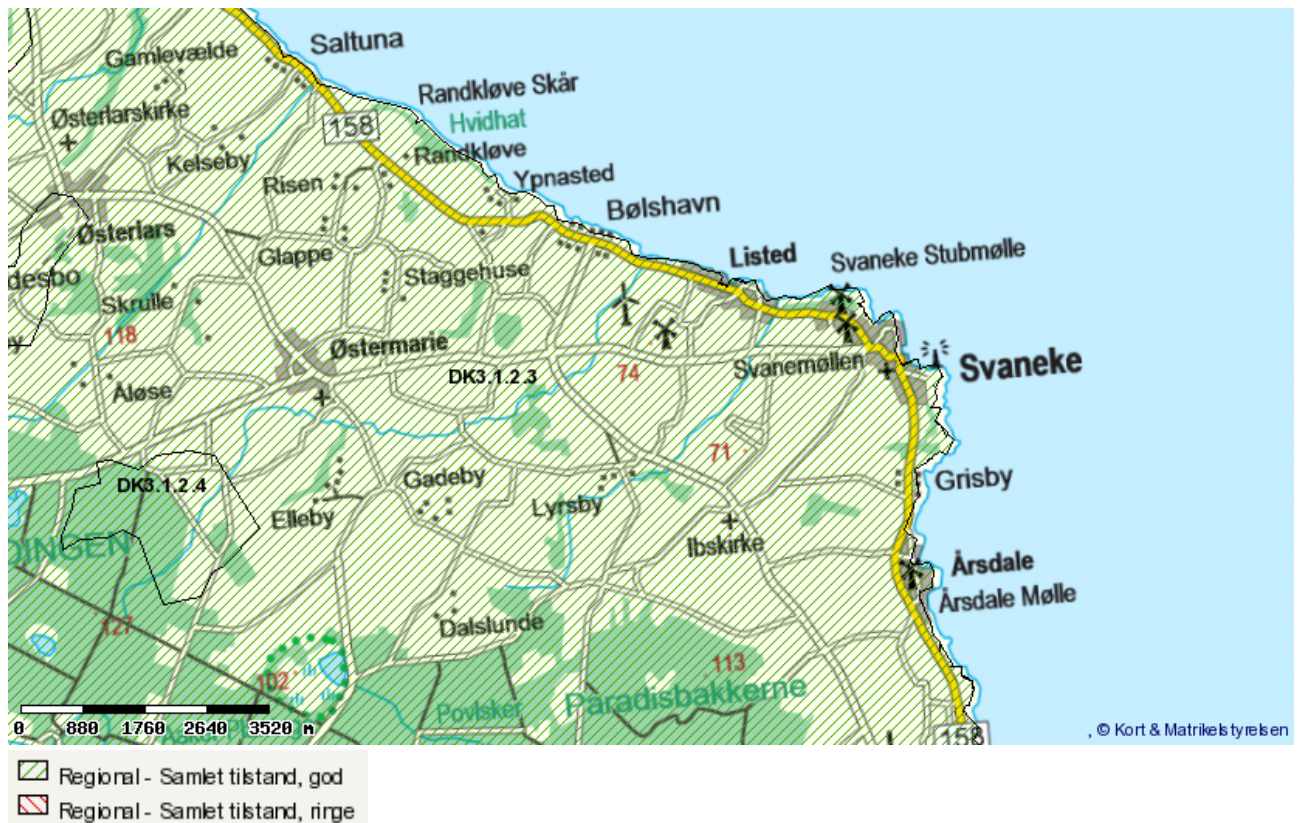
Figure 25. Regional groundwater body DK3.1.2.3 on East Bornholm (From Ministry of Environment, 2010).

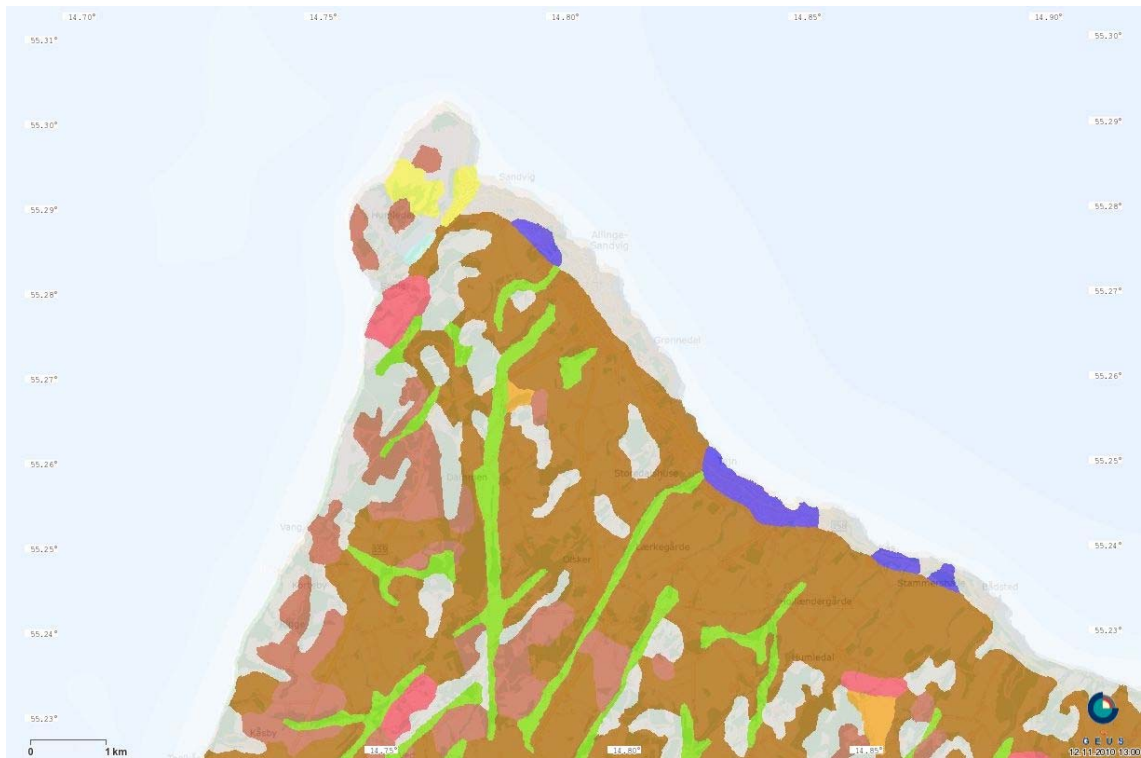
*Fig.34. Map of the Quaternary deposits (From GEUS Homepage after Pedersen, 1989). Legend: Brown: Clayey till, Red Brown: Sandy till, Red: Meltwater sand and gravel, Blue: Late Weichselian marine deposits, Green: Holocene Freshwater deposits, White: Precambrian basement.*

Most of the surface is covered by a relatively thin cover of clayey and sandy tills but the Precambrian rocks are often exposed directly on the surface (Fig. 34). Many good profiles in the Precambrian rocks are available in the quarries (Figs. 35 and 36). The Quaternary sediments are more difficult to observe.

The Quaternary cover in the areas around the quarries is very thin (Figs. 34 and 43). On the Hammeren, thin layers of clayey till and aeolian sand deposits occur but most of the area is without cover. In the fracture valley from Sæne Bugt to Osand Bugt is found meltwater sand and gravel. The Vang area is partly covered by clayey till and partly without cover. An investigation southwest of the Almeløkke Quarry on Bukkegård fields shows a clayey till cover. The thickness is between zero and 10 m.

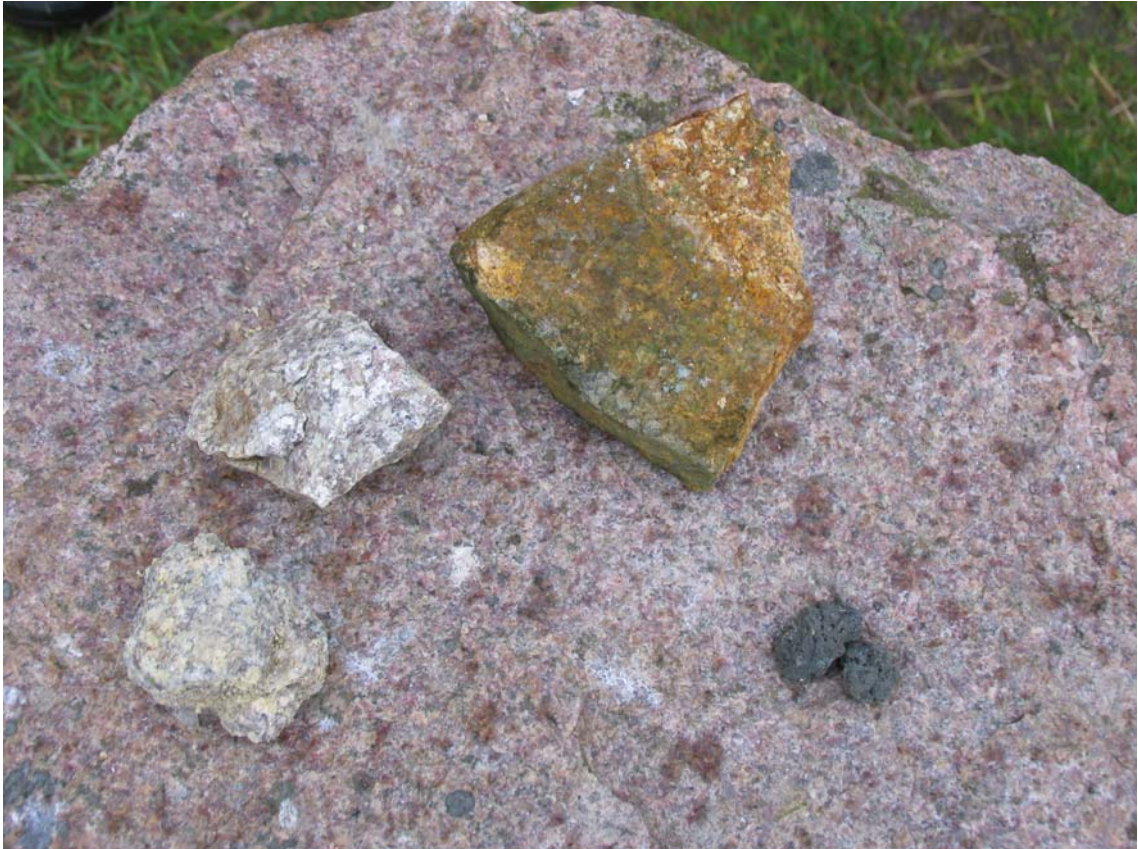
*Figure 39. Fine-grained Hammer Granite. The four smaller fragments represent different levels in the weathering process of the granite: One fragment with yellow brown weathering of iron oxides, two grey and white fragments in different degree of kaolin weathering and one black fragments of manganese oxide formed in a fracture.*

The Hammer Granite is a light grey-red, fine to medium-grained rock with characteristic small red dots of hematite which is coating on individual grains (Fig. 39). The granite contains bodies of coarse-grained pegmatites and fine-grained aplites. The mineralogy is: quartz 33 %, perthite 41 %, plagioclase 18 %, hornblende 1 %, biotite 4 %, titanite 1 %, ore 2 %, and traces of apatite, epidote and fluorite. In the feldspar and quartz rich pegmatites occurs the radioactive mineral gadolinite.

The weathering of the Hammer Granite is often related to fracture zones. On Fig. 39 four different stages of a weathering process can be seen and in Fig. 40 a strongly weathered vertical fracture zone occurs. The iron minerals are oxidised to yellow brown ochre and the rocks are altered to white kaolin. Black manganese oxide is formed in the fractures.

sional fractures (Figs. 39 and 40). The jointing systems are strongly reflected in the geomorphology at Hammeren, where the main vertical fracture surfaces form the characteristic tacked coastal morphology, and the extensional fracture orientation parallel the elongation of the Hammer Sø, the lake separating the rocky landscape Hammeren from the mainland of Bornholm.

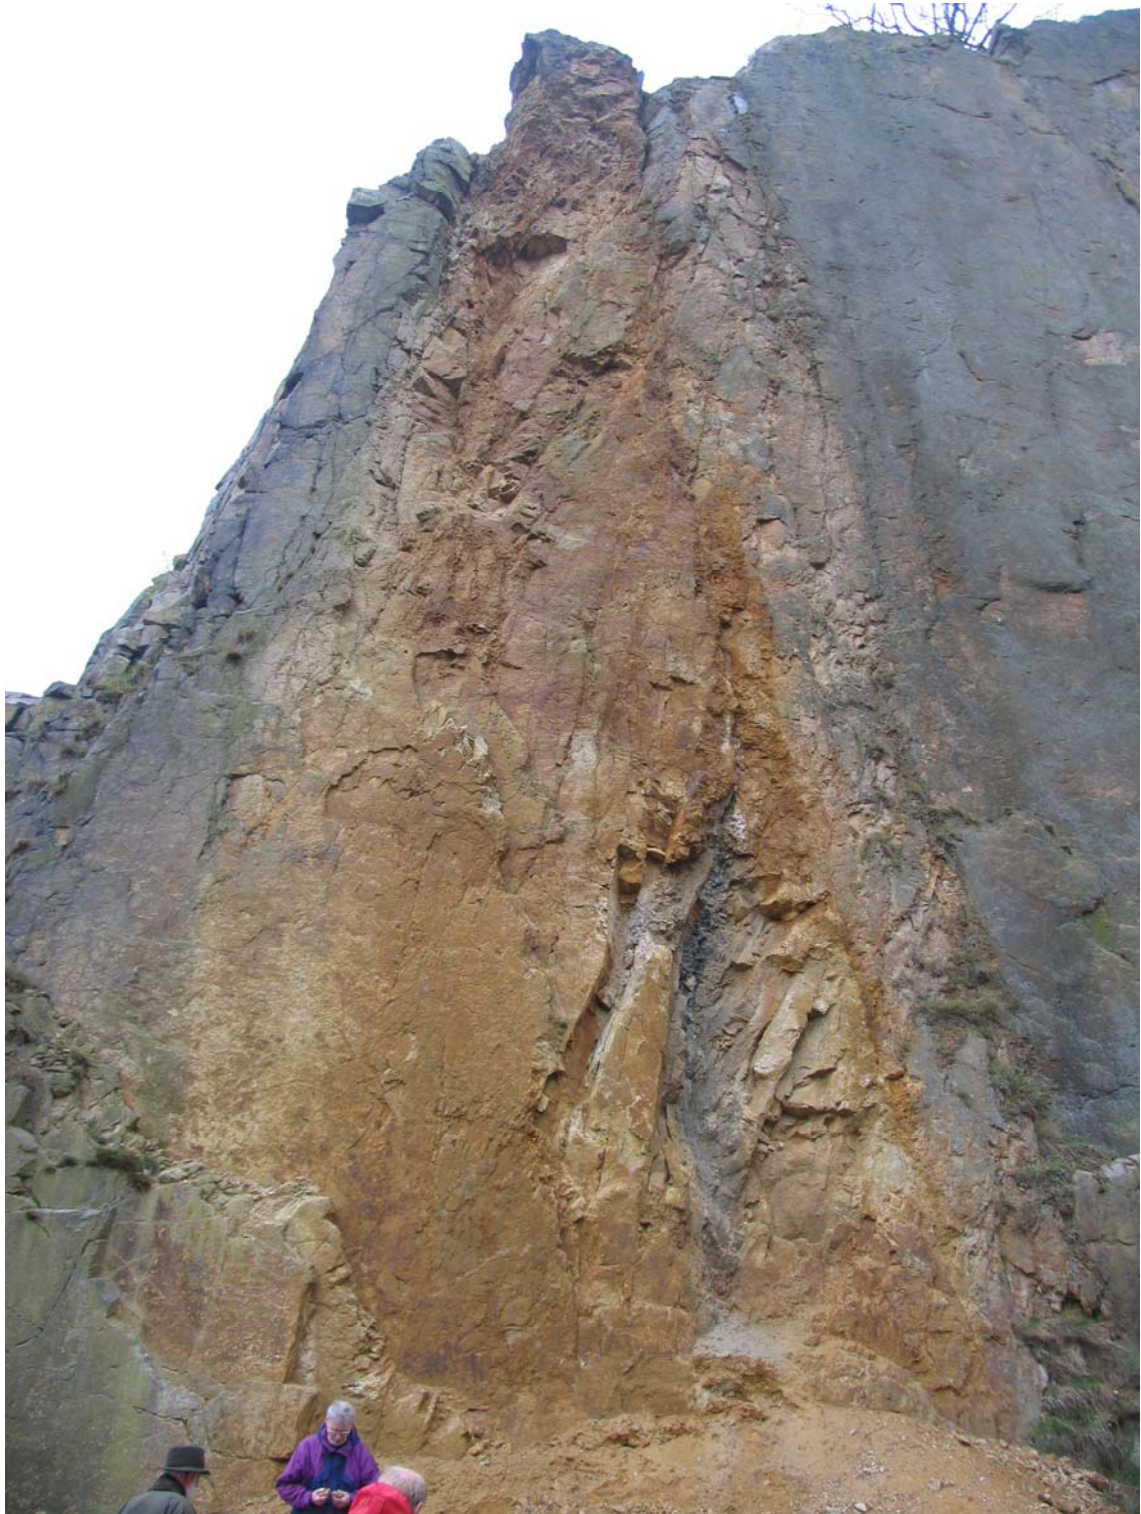
*Figure 40. Strongly fractured Hammer Granit with yellow brown weathered fracture zones. Hammeren Granite Quarry.*

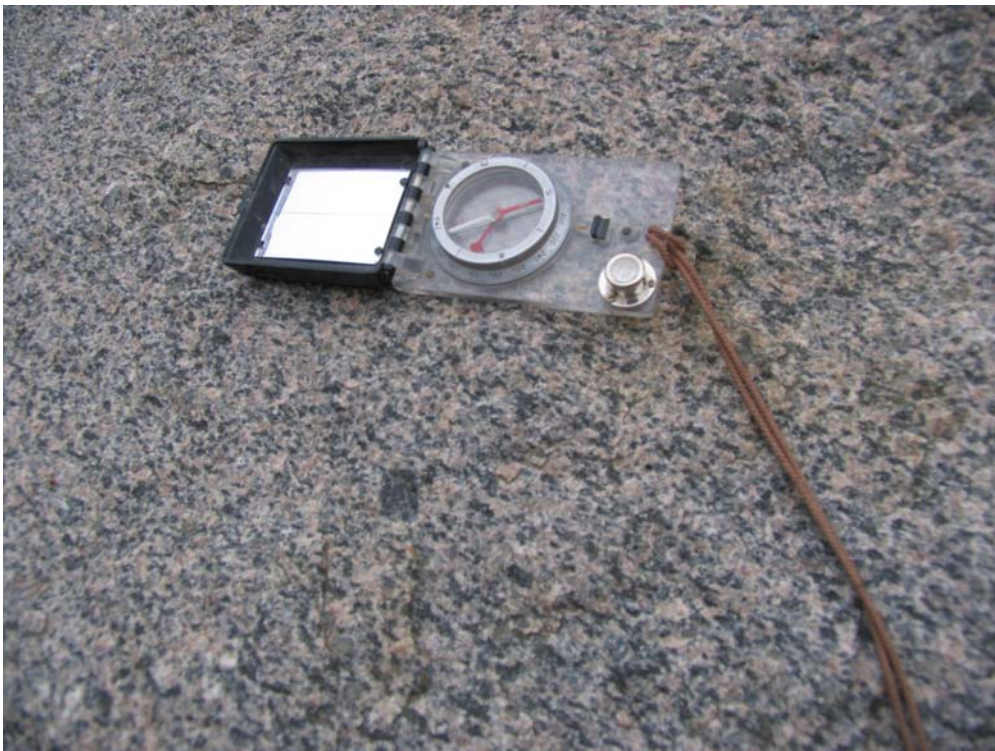
*Figure 41. The red grey medium-grained Vang Granite from the Vang Quarry.*

The Vang Granite is a medium-grained grey-red granite with many spots of dark minerals (Fig. 41). It is often weakly foliated with c. 45° dip towards the north. The foliation increases towards the south. South of the Almeløkke Quarry is a gradual boundary to the Bornholm Gneiss, which occur below the Vang Granite. North of Vang Harbour, the contact to the Hammer Granite is a weakly dipping slice under the Vang Granite. The granite contains many inclusions of older rocks and veins and dykes of pegmatites and aplites.

Along the west coast - about 5 km south of Hammeren - the old granite quarry at Vang is situated, which is considered due to its obvious constructional facilities. The Vang Granite is reasonable dense, medium-grained granite (Fig. 41). However, the granite rock at the quarry is heavily fractured by the conjugate, shear fractures orientated perpendicular to each other in the directions trending NNE and ESE. The latter of these fractures systems (ESE) has a fracture density of 3 vertical joints per running meter in a cross section perpendicular to strike (Figs. 49 and 50). Some of these fractures developed into extensional fractures with kaolinite altered breccias. The shear fractures in Vang as well as at Hammeren are interpreted to have formed during the main dextral trans-pressure in the Tornquist-Sorgenfrei Wrench-Fault Zone.

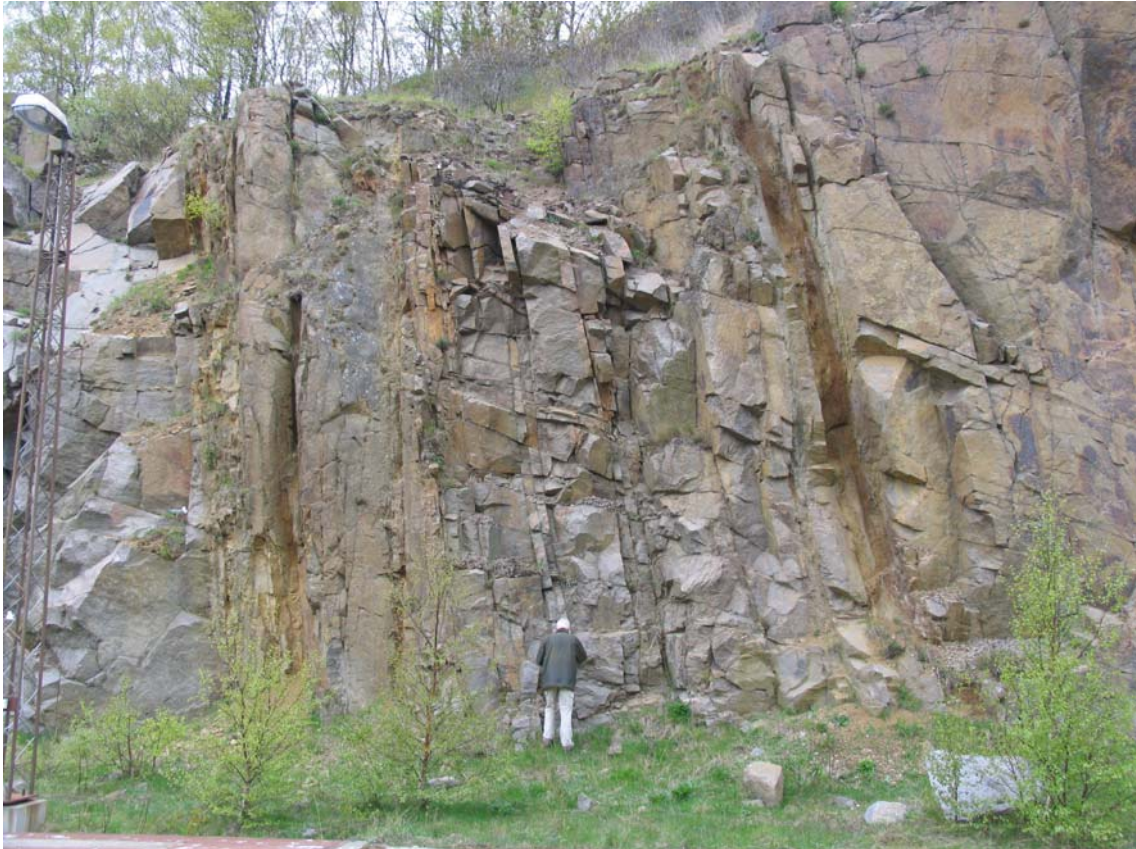
*Figure 42. The Vang Quarry: Fracture zones in the Vang Granite with yellow brown coloured strongly weathered parts.*

The granite is strongly weathered in some of the fracture zones. The yellow brown colour indicates weathering of minerals with iron content. The plagioclase, weathered to sericite and chlorite is also found in the fractures (Fig. 42).
