**Low- and intermediate level radioactive waste  
from Risø, Denmark. Location studies for  
potential disposal areas. Report no. 4**

Characterization and description of areas  
Bornholm

Peter Gravesen, Bertel Nilsson,  
Stig A. Schack Pedersen  
& Merete Binderup

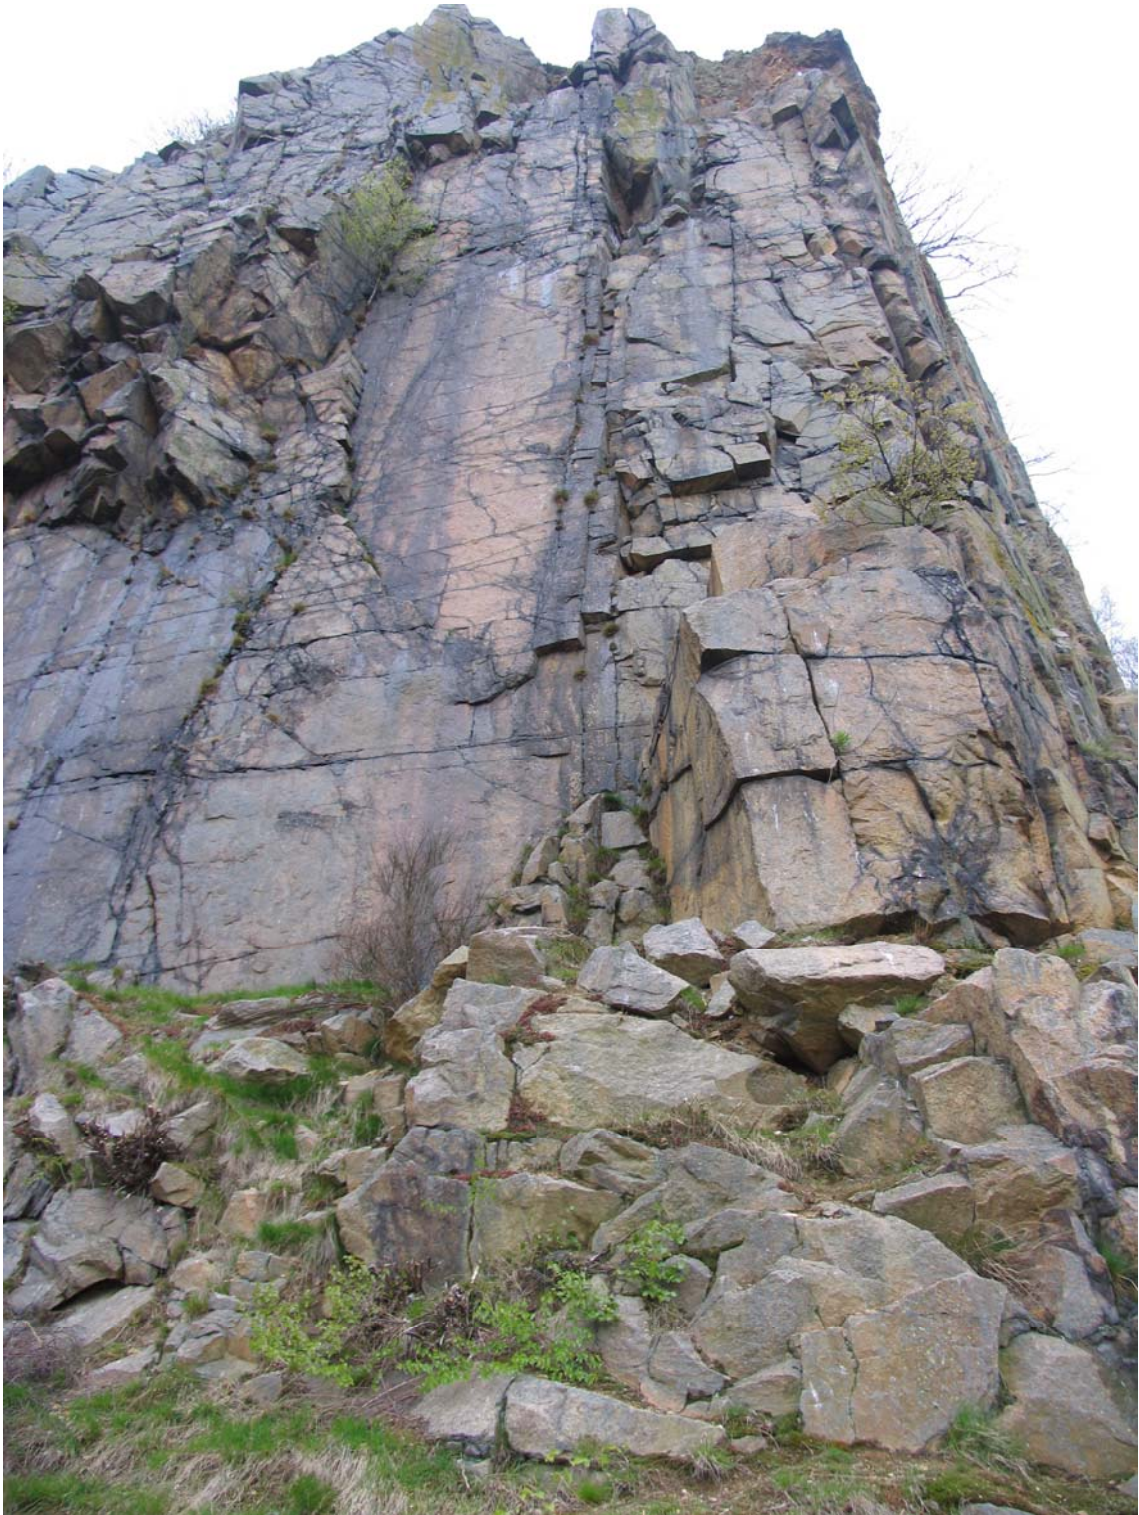
*Figure 45. Hammer Granite, Hammeren Quarry. The granite is cut by many fractures.*

The fractures in the Hammer Granites have been investigated and measured for many years. The granite is cut by several pronounced fracture systems with orientations N-S, NE-SW and NV-SE. The vertical spacing is between few cm and 2–3 m. The horizontal spacing can be up to several meters and is probably increasing downwards (?) (Fig. 45). As a consequence of the many vertical and horizontal fractures, the rock can have a blocky structure (Fig. 45).

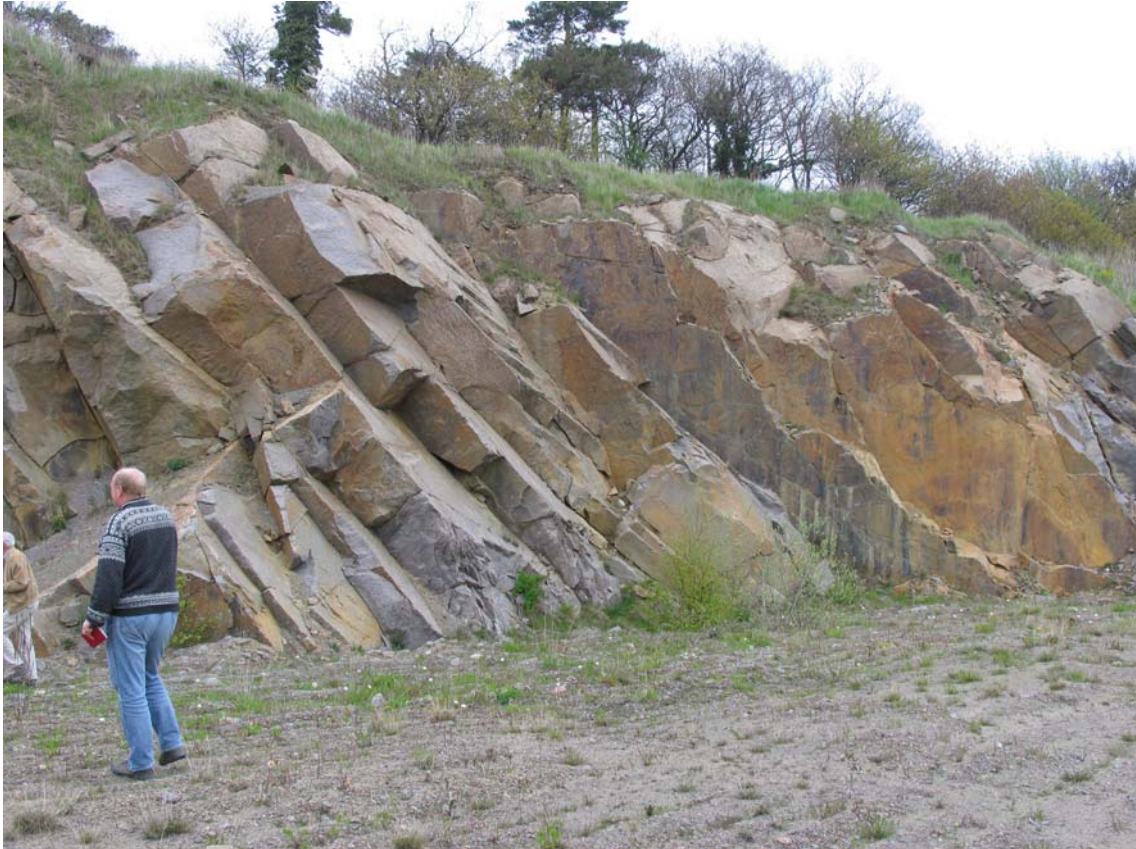
*Figure 46. Vang Granite, Almeløkke Quarry. The granite is cut by inclined fractures.*

The pattern in the Almeløkke Quarry is a dominant ESE-WNW direction of steep fractures but in some part of the quarry the directions are NNE-SSW, NE-SW or NNW-SSE. Some of the fractures are inclined  $45^{\circ}$  towards NE (Fig. 46). The spacing seems to be larger here than in the Vang Quarry.
